# Installing new seacocks

Ali Wood swaps the corroded and unsuitable metal seacocks for smart new composite ones on the Maxi 84 PBO Project Boat

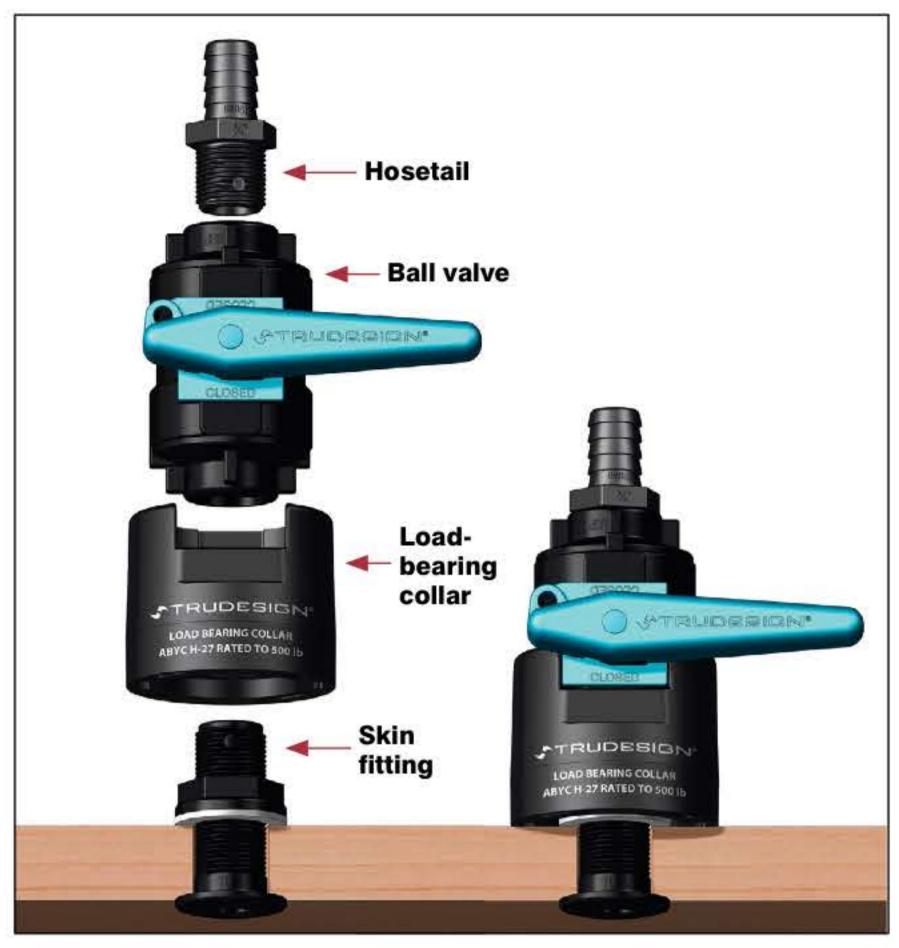
**LEFT** How the composite TruDesign skin fitting and seacock attach to the hull **BELOW RIGHT** SeaSeal cone valve seacocks in 11/2 in and 3/4 in sizes

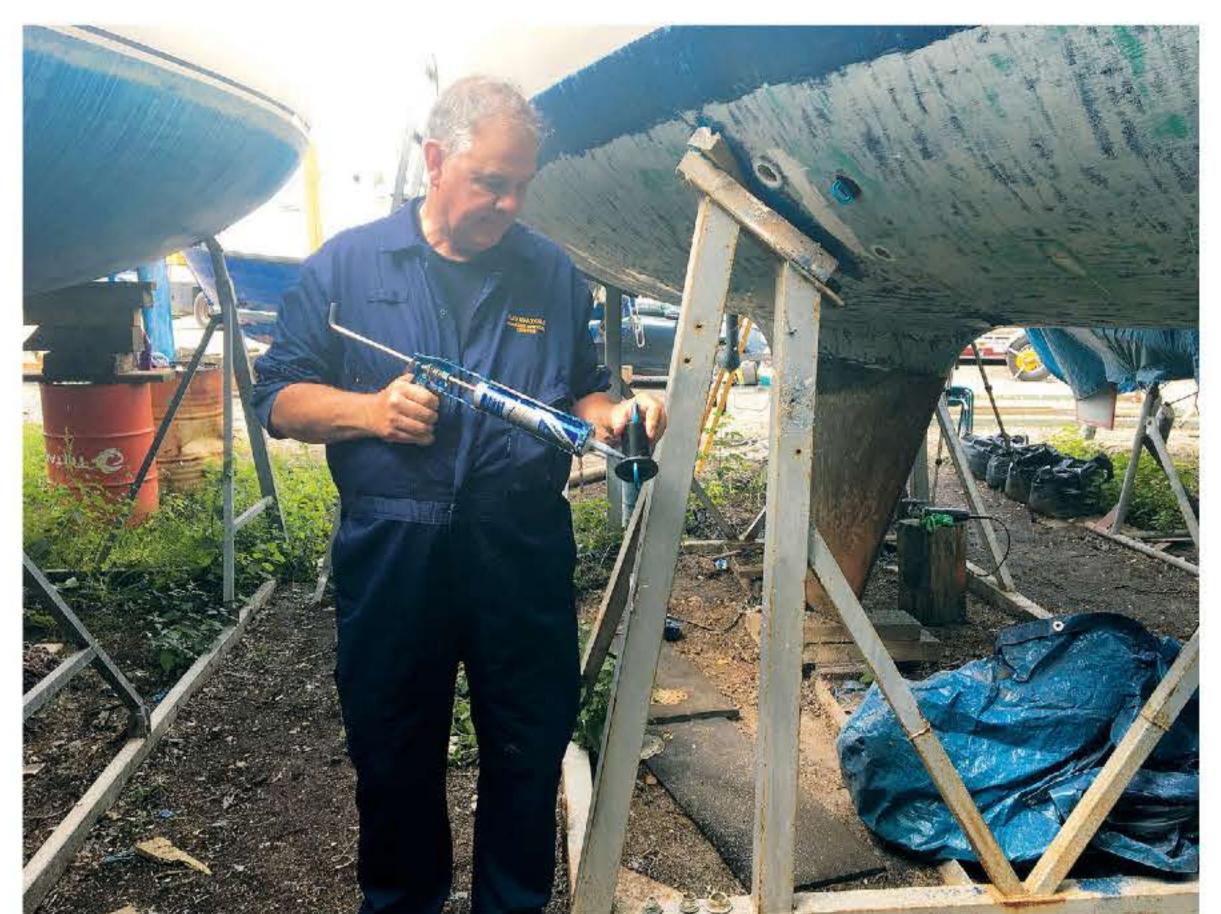
ABOVE Peter Draper adds sealant to the TruDesign skin fitting. Note the application tool is inside it. On the hull you can see he's done one already. TOP RIGHT Cutting out the old fittings. ABOVE RIGHT The old seacocks on Maximus were cut away

Peter cleaned the holes thoroughly to give the sealant the best chance of adhering to the laminate. He then abraded the area inside, outside and across the laminate and applied a good helping of sealant.

Using the installation tool, Peter placed the fittings in the hole and then removed the tool. Rather than wiping away the excess sealant, he left it to cure, ready to be cut away in the morning.

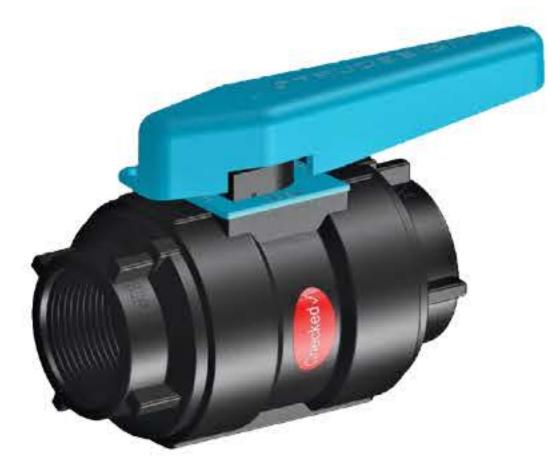
A TruDesign composite ball valve assembly

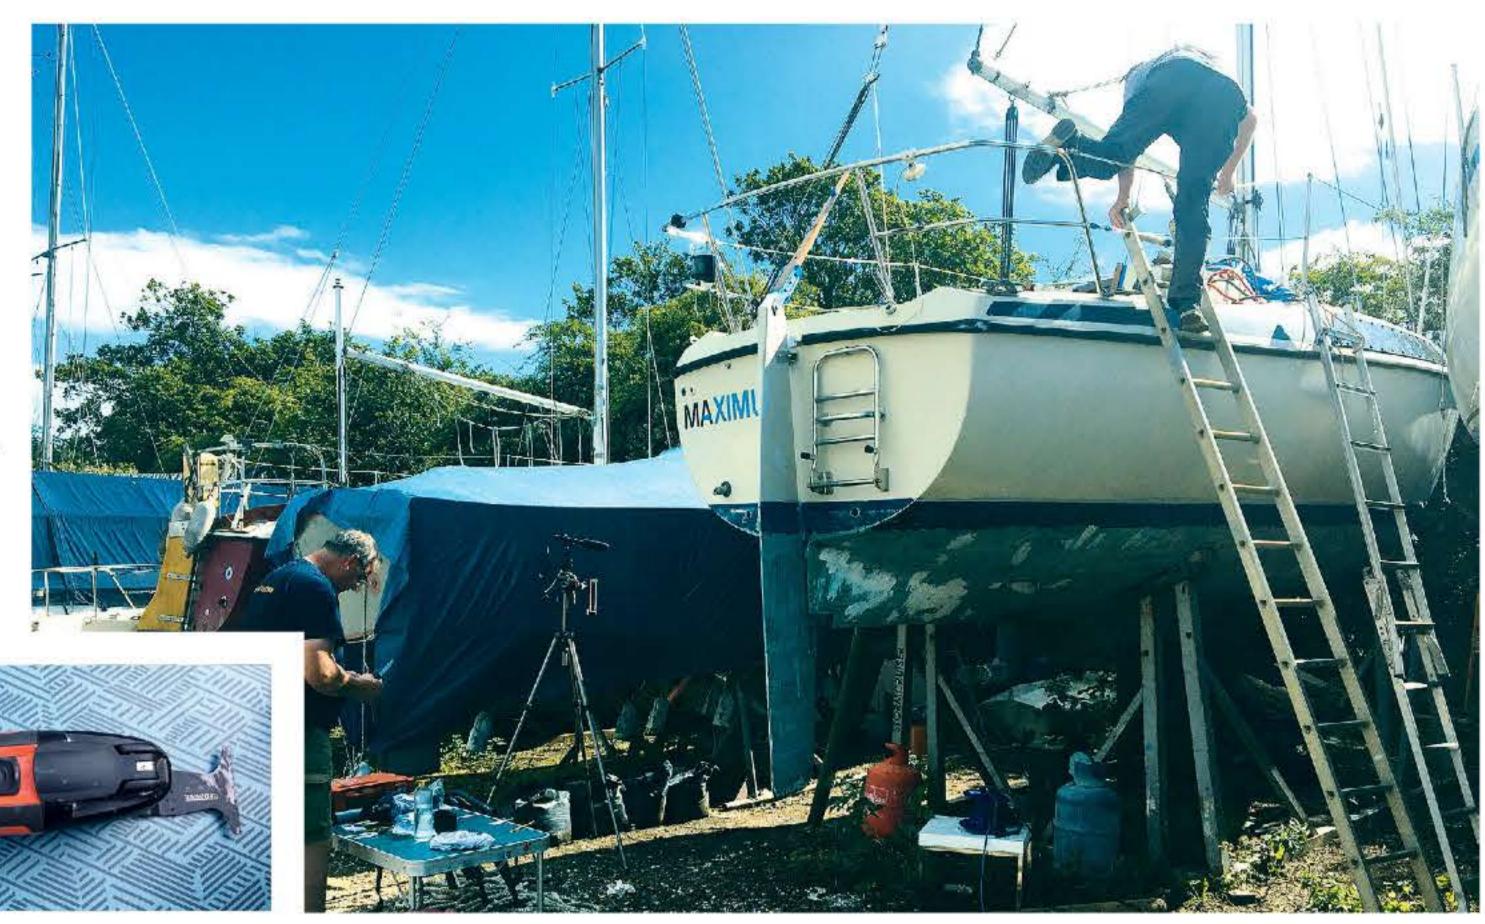
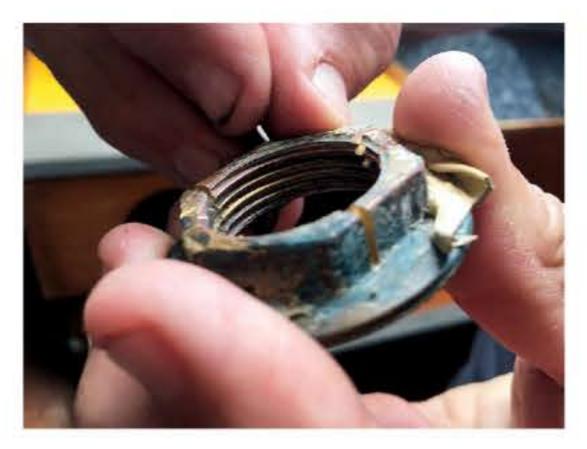
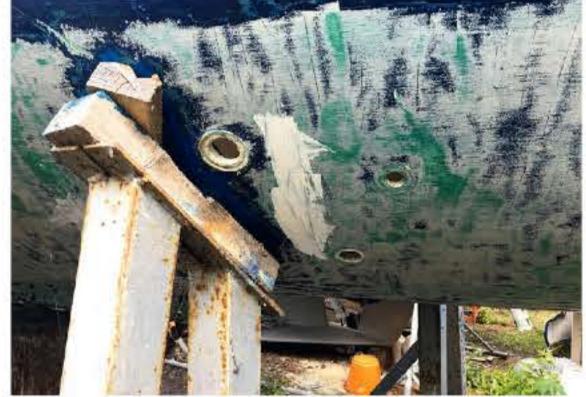
RIGHT Up and down on the ladder! **BELOW Multi-tool** was used to cut away the old skin fittings **BOTTOM Pink** thread inside the old gate valve shows where the zinc has leached away **BELOW RIGHT Holes** in the newly scraped hull where the skin fittings used to be

which would have been the 43-year-old original fitting. He explained that the pink colouring was evidence that the zinc had disappeared from the alloy, suggesting the old gate valve wasn't bronze as first thought, but brass and – now that the zinc had leached away – largely copper! It's a good job it was replaced as it could have disintegrated at any time.

Peter started by cutting out the old fittings, using a multitool for the awkward corners. Once the nut was removed the skin fitting could be pushed out from the inside. It was interesting to see just how corroded the assemblies were.

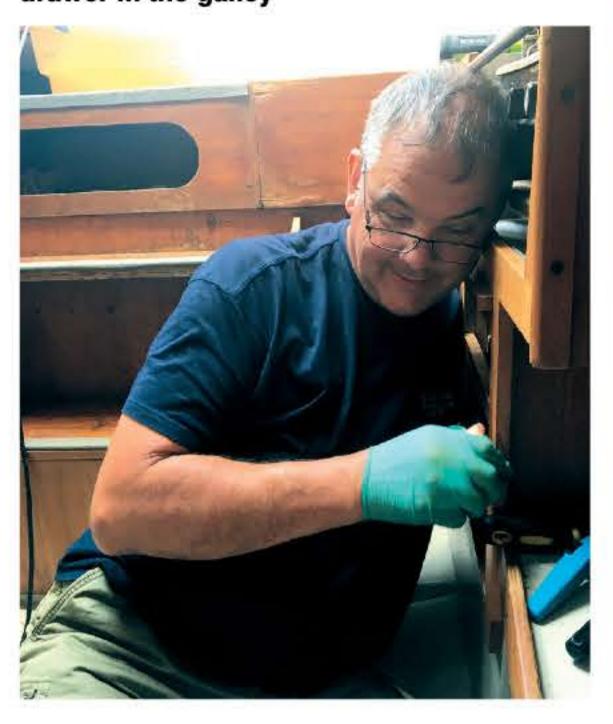
In the galley, the gate or 'sluice' valve looked to be bronze, which is much better, but it was completely seized. None of us could turn the handle and there was corrosion on the castings.

#### **BELOW** The sink gate valve was inconveniently hidden under the bottom drawer in the galley

The valves in the heads went in easily enough, but it was certainly a fiddle for Peter trying to replace the old gate valve in the galley, which was positioned underneath a tiny drawer with barely inches to move around.

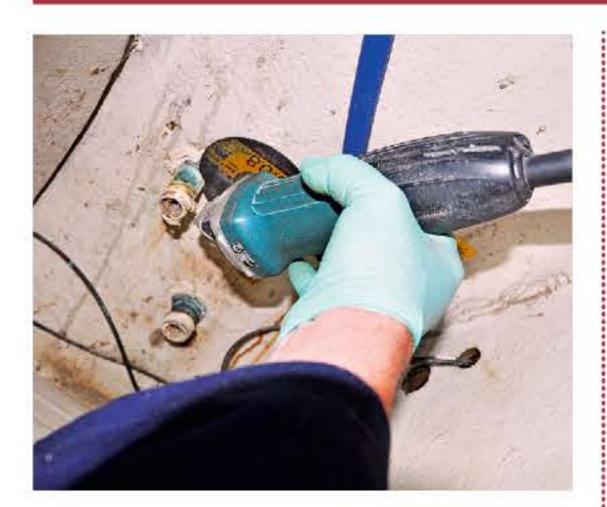
Remove the old fitting. A multitool comes in handy for cutting in those awkward corners.

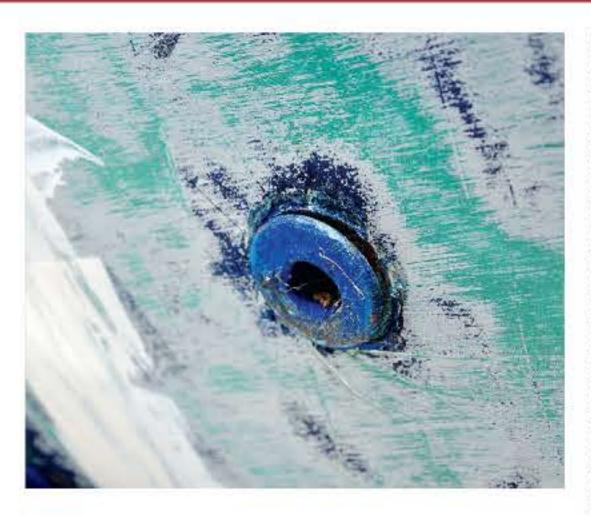
Once the nut is removed from the inside, push the skin fitting out through the hull.

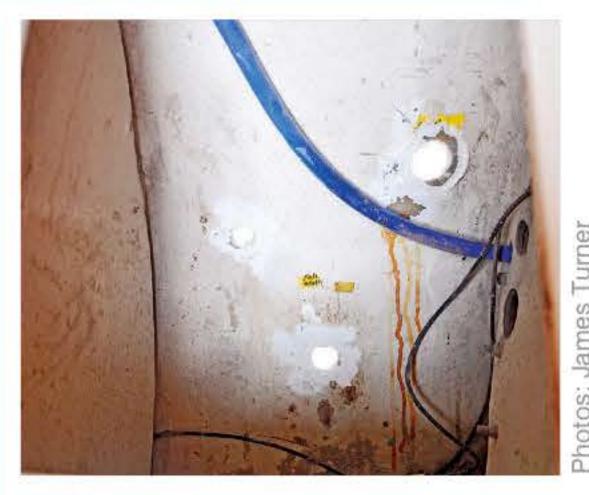
Abrade and clean up around the holes to give the sealant the best chance of sticking.

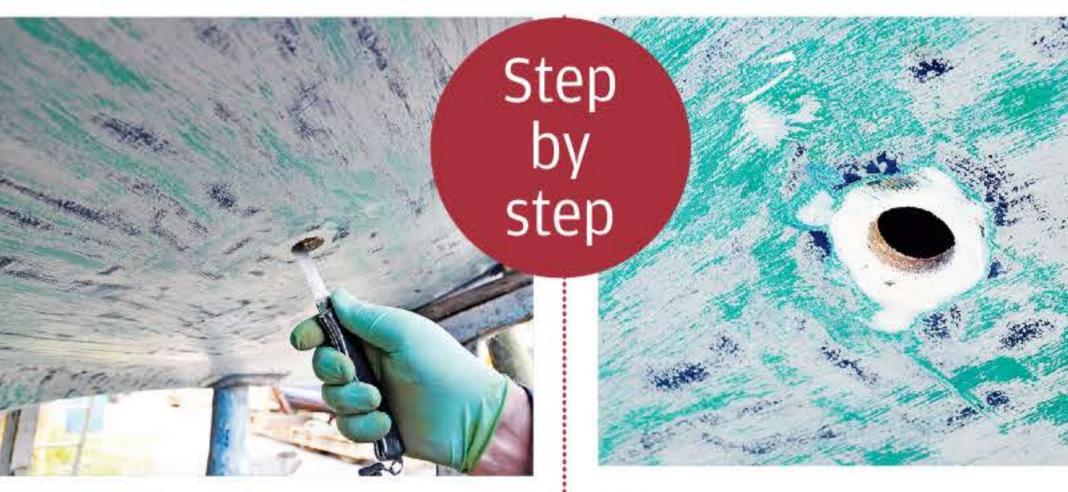
On the outside, make sure you remove all the old sealant.

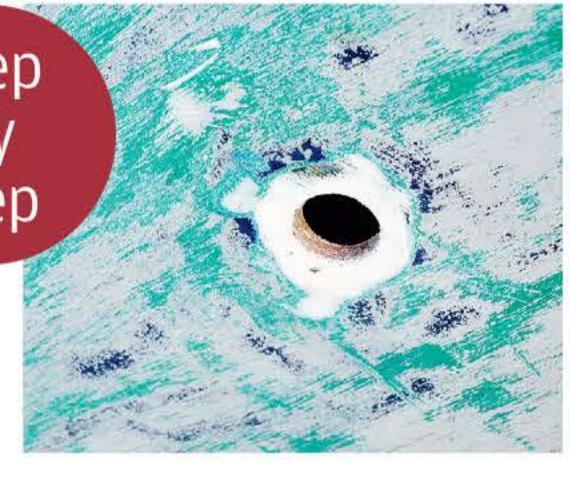
Abrade and clean up, same as for the inside of the boat.

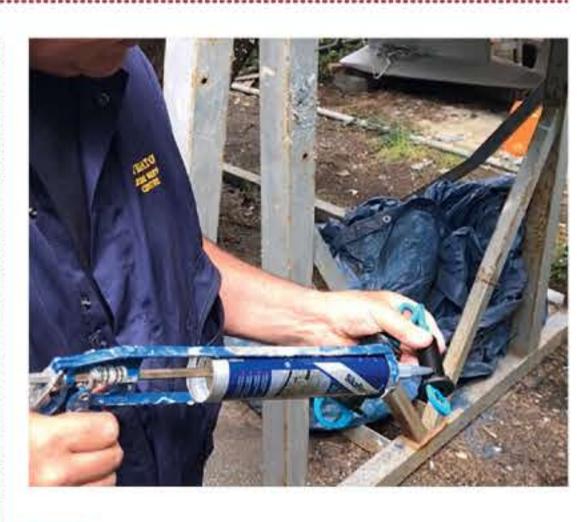
Apply a good helping of sealant to the skin fitting flange...

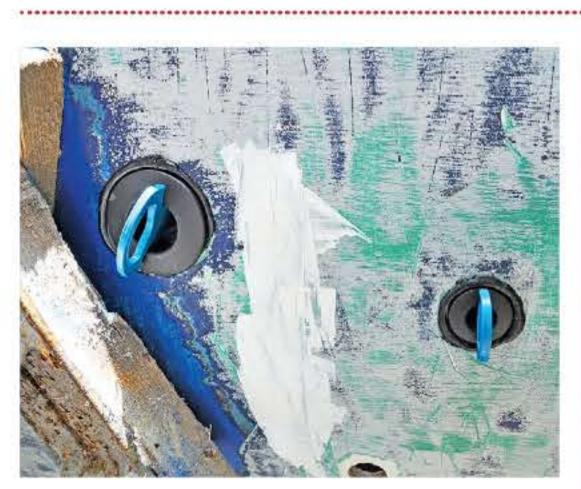
... and push the fitting into the hole. Installation tool helps avoid mess.

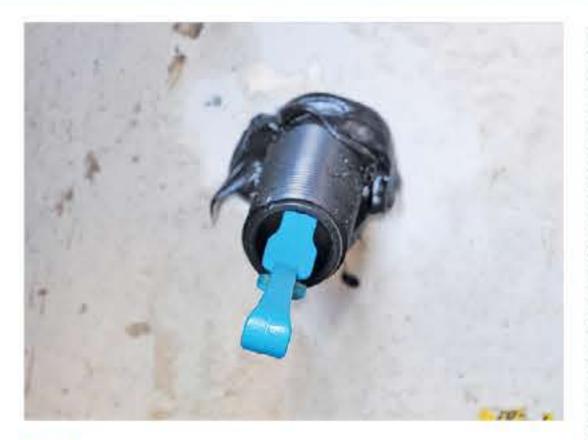
Inside, ensure there is sealant between the hull and washer, and between washer and nut.

It's important there's sealant between the hull and washer and between the washer and nut, so to ensure this the nut need only be finger-tight so it doesn't squeeze all the sealant out, allowing the sealant to do its job.

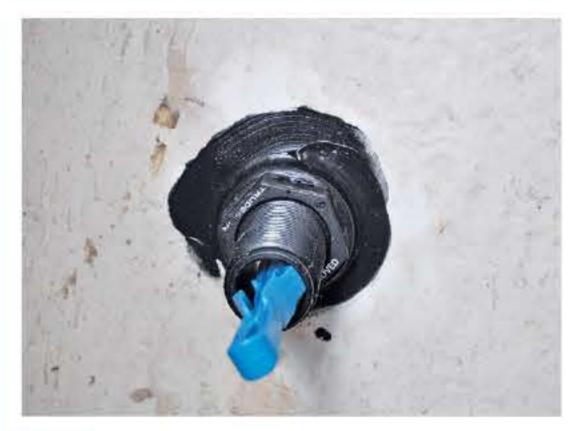
Do up the nut finger-tight only, then wipe away excess sealant. Leave overnight for the sealant to cure.

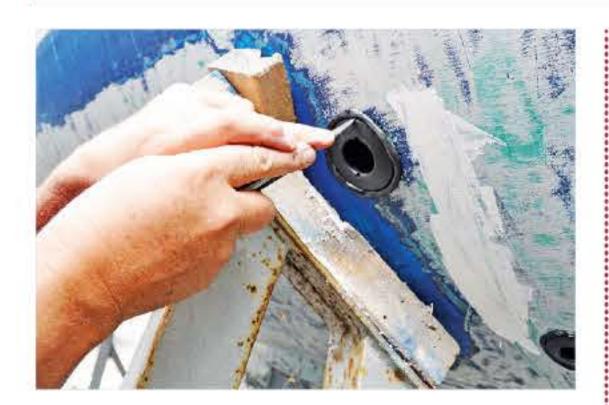
Carefully cut away excess cured sealant on the outside of the hull with a sharp knife.

The following morning the sealant had cured nicely and Peter cut the excess away with a sharp knife.

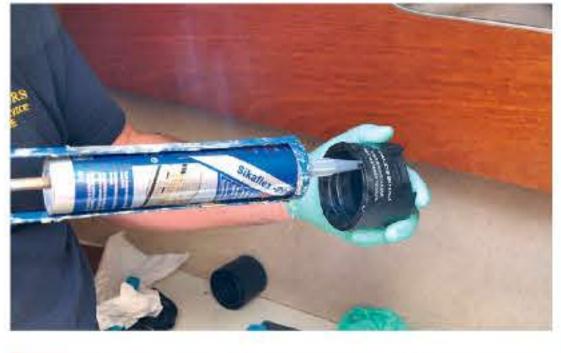
Inside, cut off any excess length of the skin fitting and fit the loadbearing collar and valve. Use sealant on the joints but keep the ball valve clean.

Again he used the multitool, this time to cut away the excess length of the skin fitting; as you never really know when dry-fitting how much thread will be left inside the hull it's best to leave this job until after the sealant has cured.

Still, he managed. He used sealant for all the joints, but was careful not to get sealant into the centre of the valve where it could clog up the smooth operation.

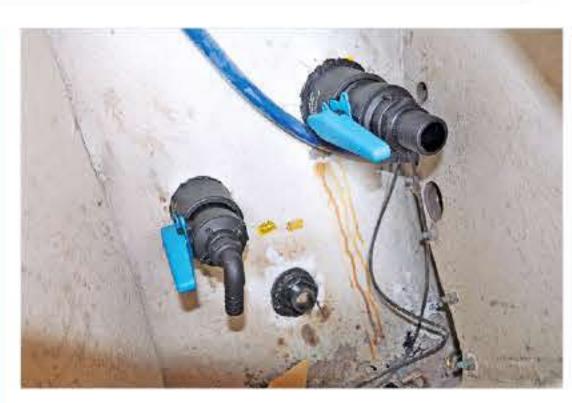
Screw in the hose tail. Leave everything to cure overnight before attaching and double clamping the hose.

We then needed to wait 24 hours – again for the sealant to fully cure – before replacing the hoses.

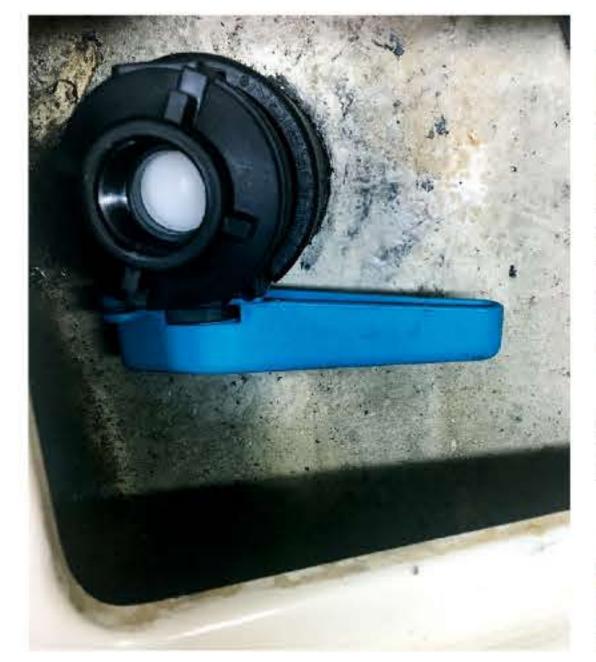
TOP LEFT Here you can see the seacock is closed and the 'ball' in the ball valve is blocking the hole LEFT Ali getting accidentally locked in Peter's van was the only hiccup to the day's events

With no hoses attached, it was quite good fun to open and close the ball valves, and see first-hand how they work. When you see daylight streaming in from under the boat, you realise just how important these little fittings are, and why it's important to keep them in good nick!
